Instituut vir Termodinamika en Meganika – Institute for Thermodynamics and Mechanics

Orgafle Cabinet Compression

Report by:
Ockert Strydom

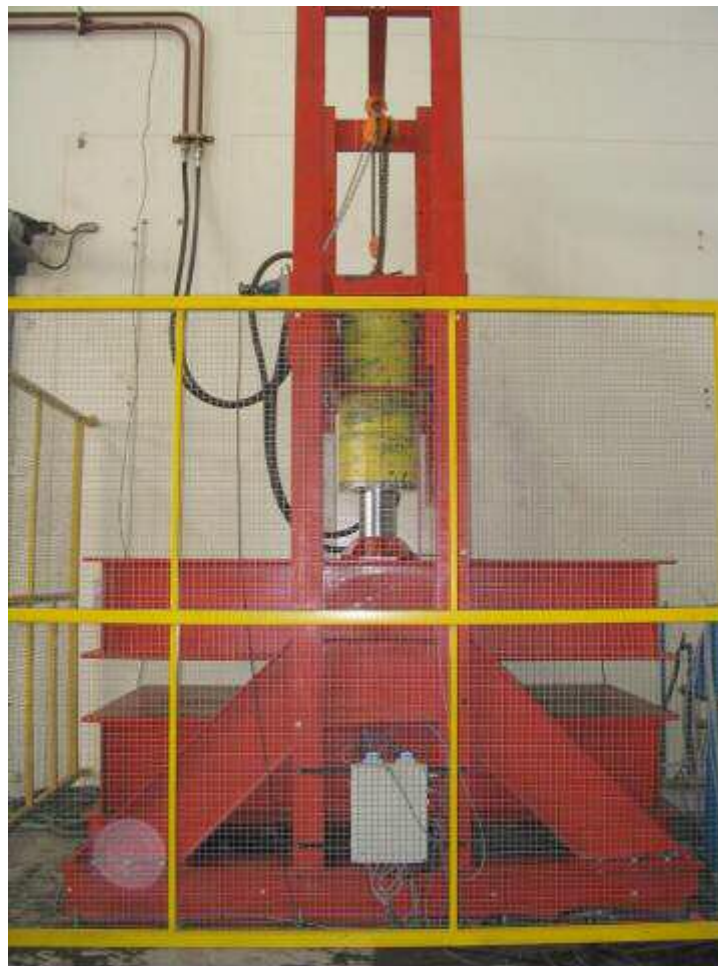
The test was done in a 1400 kN Static test frame. The load was measured using four 10kN HBM S9 load cells. The four load cells were fixed to a load plate and the data sampled simultaneously. Data acquisition and signal conditioning was done with a HBM Spider8-30 and sampled with a lap top computer running Catman 3.0 software.

Figure 1: Test Frame

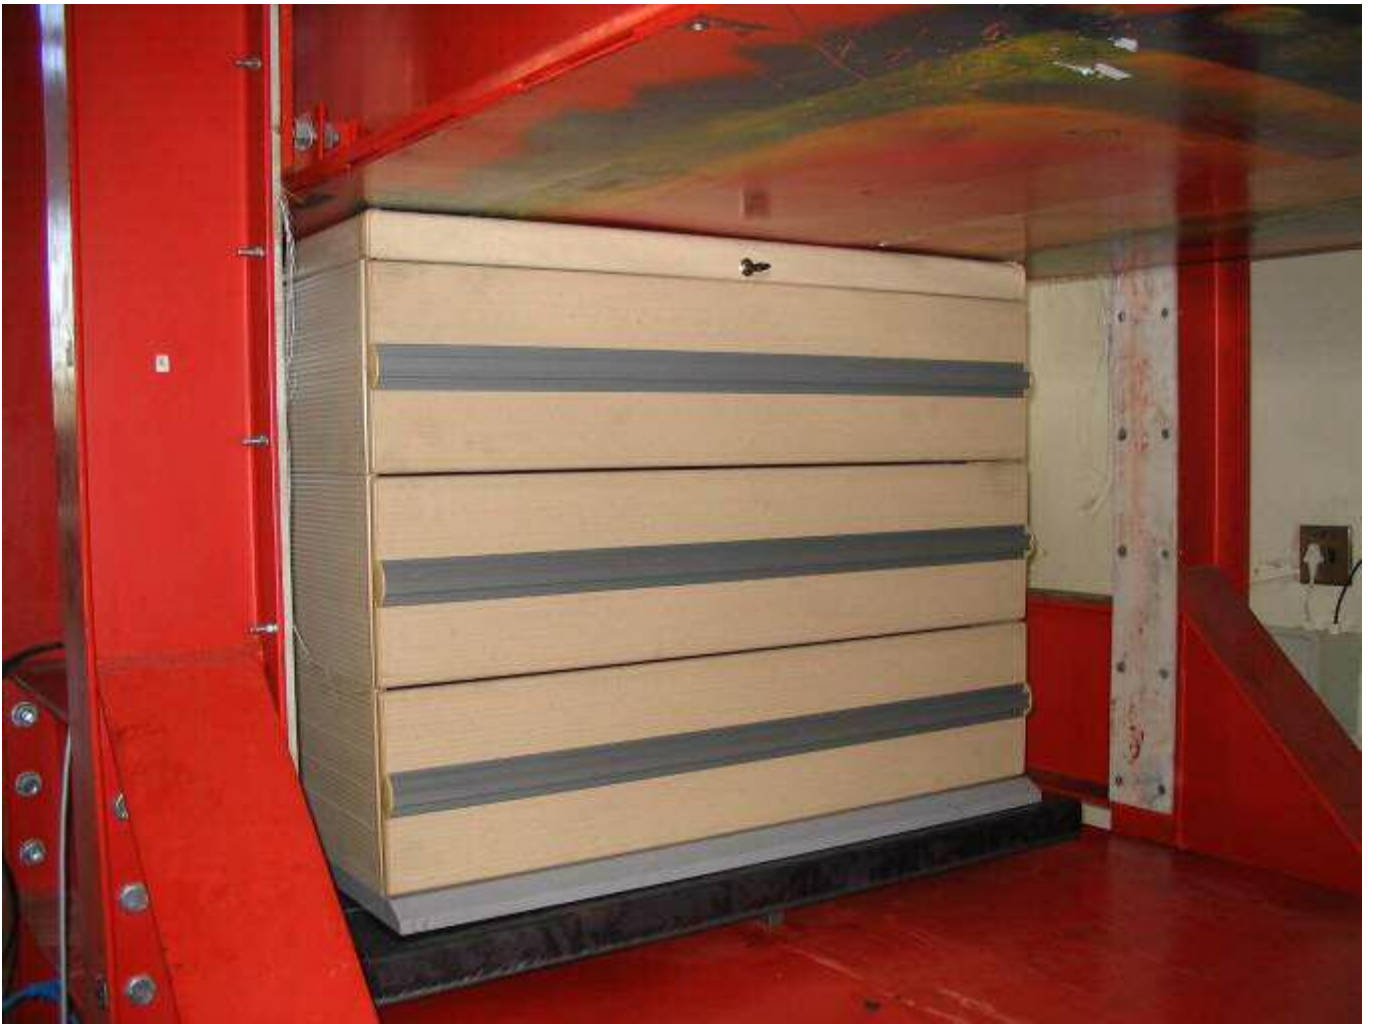
Because of the difficulty in simulating proper boundary conditions on a single side panel it was decided to test the complete cabinet.

Figure 2: Orgafire Cabinet fitted in the test frame

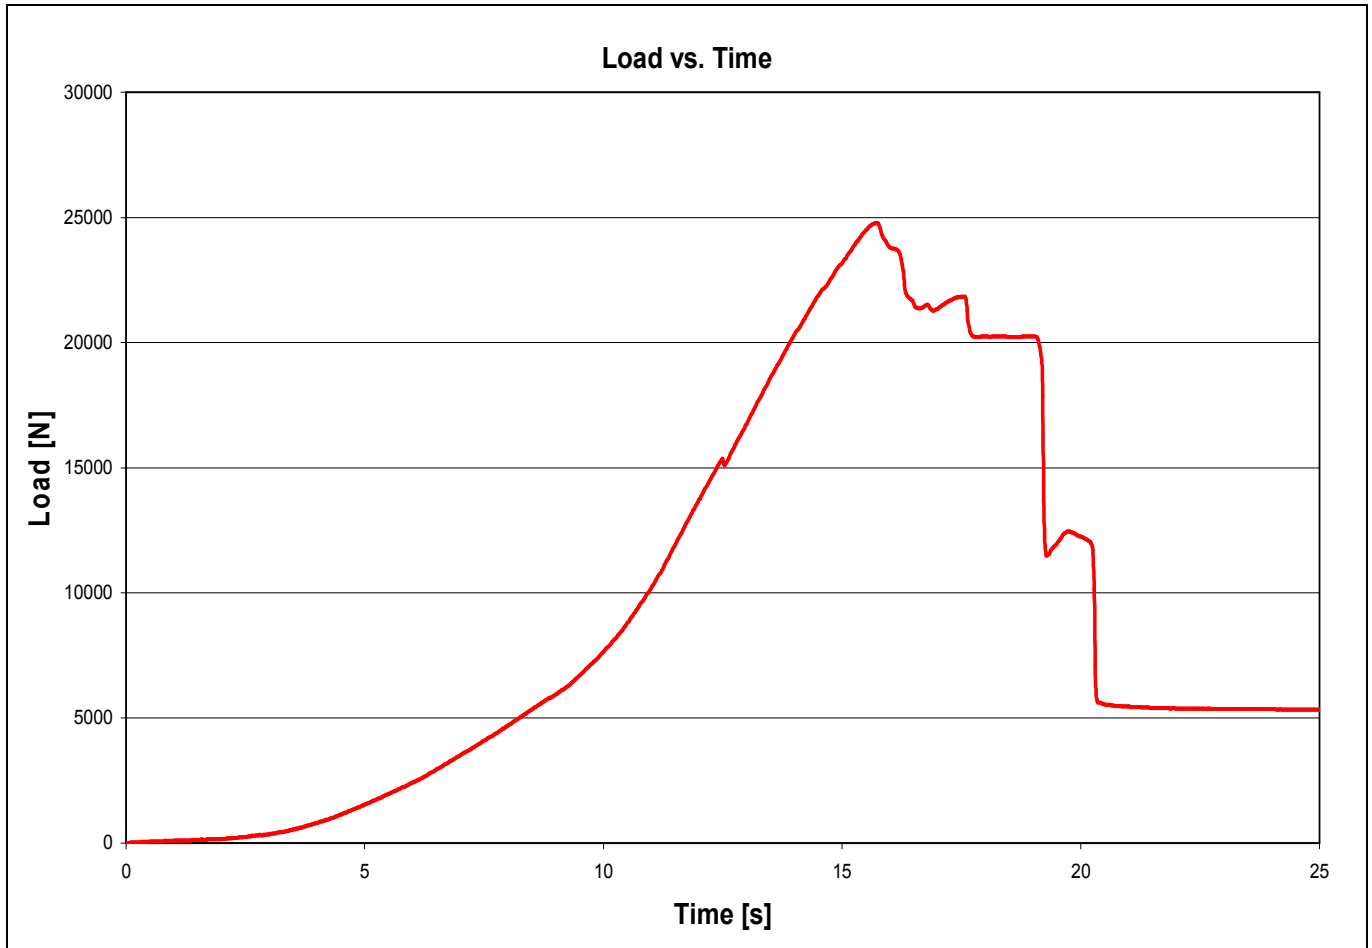
The load from the four load cells were summed to give the total load. As can be seen from Figure 3: Load versus time, the ultimate compressive load of the cabinet is 24.74 kN.

Figure 3: Load versus time.

A OrgaFile cabinet was tested to destruction to determine the ultimate compressive load. The cabinet failed at 24.74 kN and remained intact after failure.

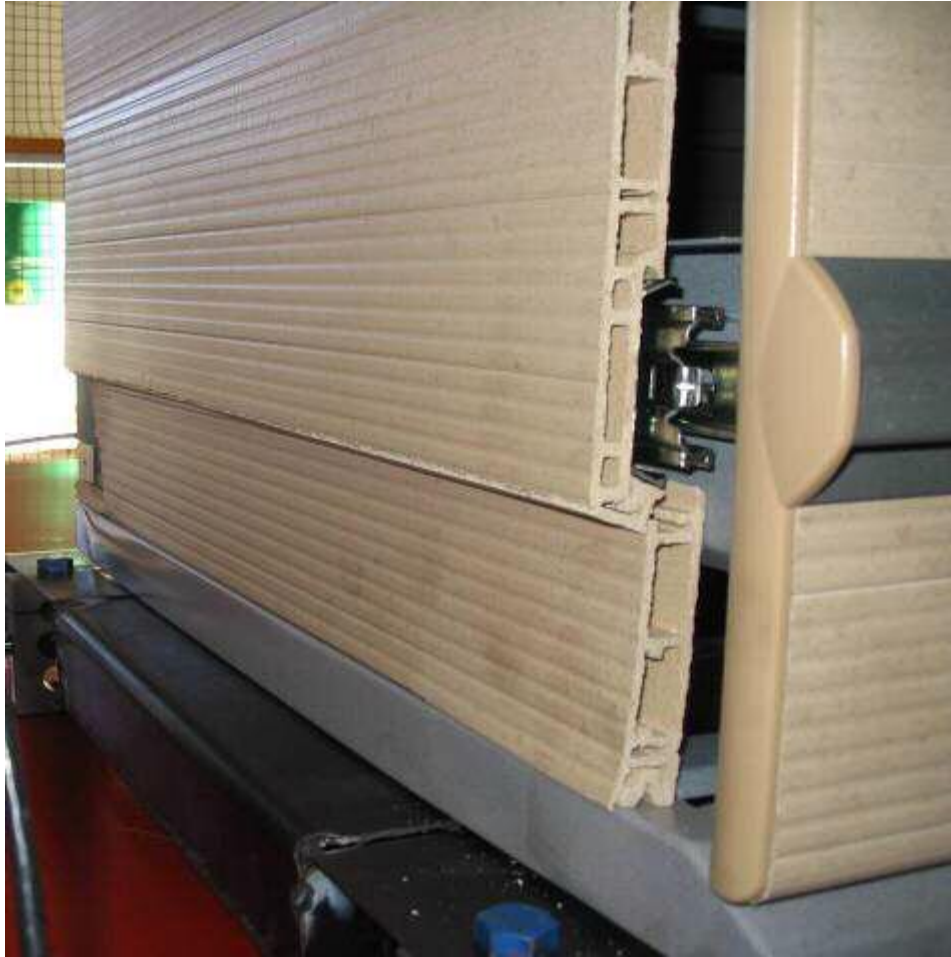
Failure of the cabinet, resulted form local compressive fracture of the side wall at the slide mounting position. After force removal the cabinet remained intact. This is a desirous safety feature in furniture

Figure 4: Failure of the side panel.
